# **RESTORATION AND REHABILITATION OF KRISHNARAJA SAGARA**

## **MASONRY DAM BY POINTING AND GROUTING**

### **(A Case - Study)**

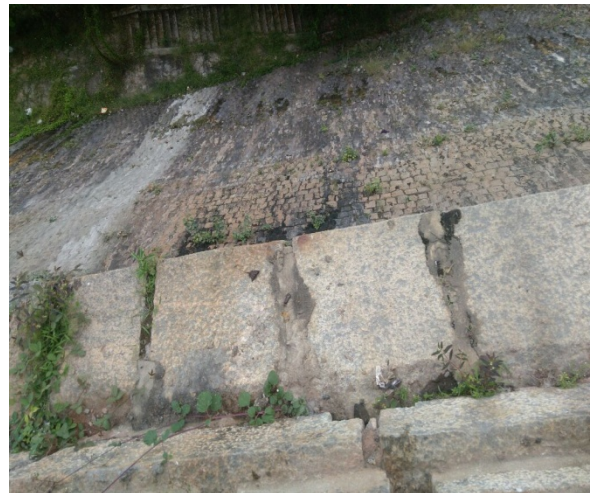
**BEFORE T-POINTING**

The cavity and masonry joint of 5 cm depth were filled with special repair mortar. The mortar was cleanly and neatly finished on surface with raising on rock surface to minimum 10 mm on all sides and 10 mm thick on original masonry surface. (T- Pointing). A curing time of 3 days was allowed for mortar.

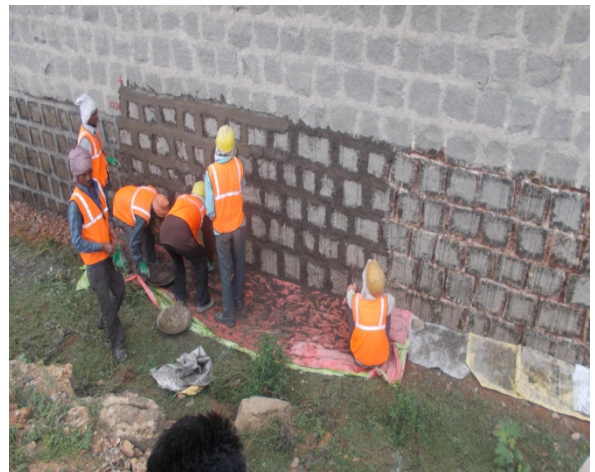
**AFTER T-POINTING**

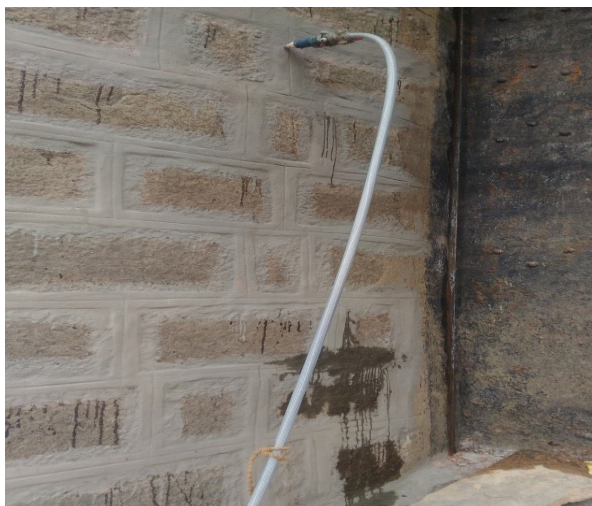
To consolidate the upstream face where ever deep cavities were seen during racking of the old mortar for Pointing and in the pier portion, special nipples of 10mm dia were installed and fixed with the mortar. These nipples were later used for pumping the low pressure grout to fill the cavity in the upstream face. The grout mixture consisted of water, cement and Admix as recommended by Central Water and Power Research Station (CWPRS). The amount of grout injected into the upstream face is recorded with respect to the time and the record for the same has been maintained. The figure below shows the grout being injected through Nozzle installed in the Pier portion.

**NOZZLE INSTALLED IN THE PIER PORTION**

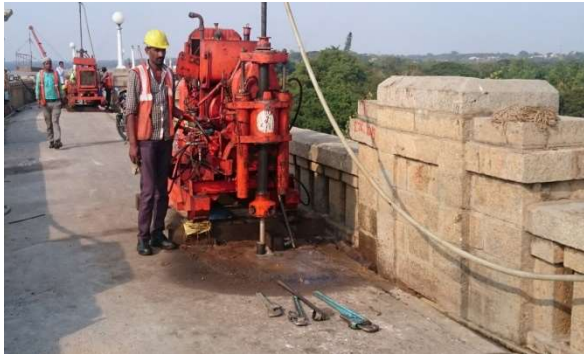
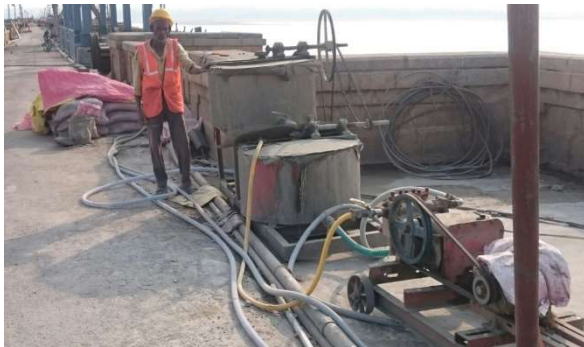
Drilling has been done by using Rotary diamond drilling rigs (Rotary method) with water flushing system. Rotary (Diamond) drilling is recommended for drilling in weak and porous masonry dam, but it is very expensive and slow in progress.

**DRILLING & GROUTING WORKS IN PROGRESS**

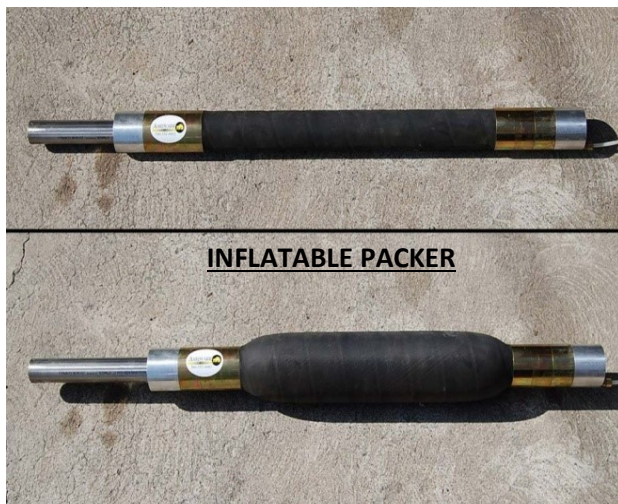
A water loss test was carried out in alternate stage of a hole. For each water loss test, water is injected under pressure into the hole for a period of not less the 10 minutes. The quantity of water loss is measured for this period. The Lugeon Value is calculated by the following equation:

A schematic diagram of the arrangement for the Water Loss Test is shown below:-

**PACKER ARRANGEMENT**
